# Volunteer Satellite Distributors

## Repairing A Mistuned UHF Can In A DSR920 – page 1

## Repairing A Mistuned UHF Can In A DSR920 – page 2

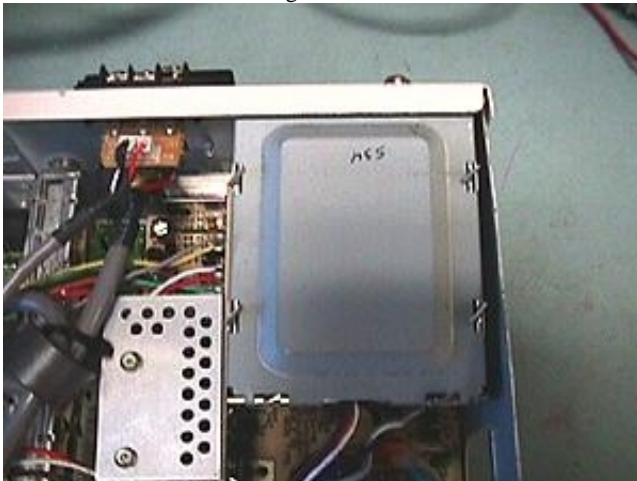
1. Unplug the 4DTV IRD.
2. Remove the top cover of the receiver by removing the four Torx screws on the sides.
3. Locate the UHF "Can" in the right rear of the unit as viewed from the front. See Illustration 1 for help in identifying the UHF "Can."

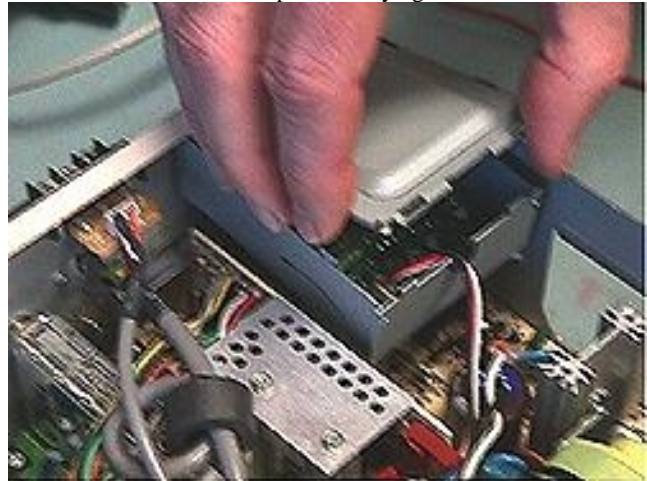
Illustration 2

4. Using a pair of needle nose pliers, carefully straighten the tabs holding the top of the UHF can in place. Remove the cover to the can. See Illustration 2.
5. Inside the UHF "can" you will see a small printed circuit board. On that board are two coils which set the reception frequency. The white arrow points to the two coils. See Illustration 3

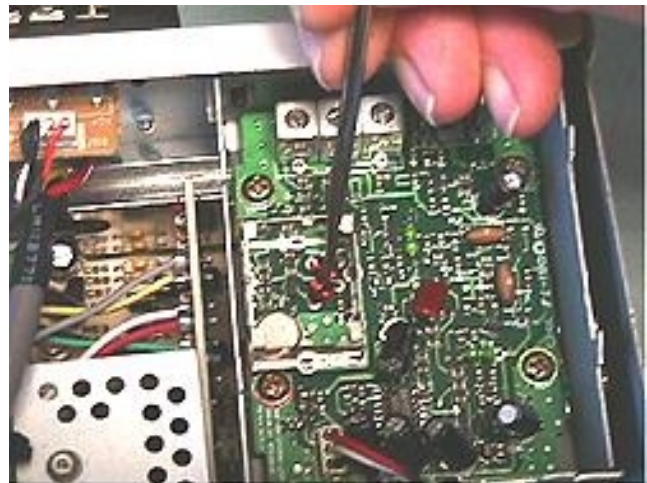
Illustration 4

The likely cause of the failure is the tuned UHF reception "can" that is attached (internally) to the UHF whip antenna. The UHF can is, essentially, a radio receiver. What has happened is that the frequency (the channel, if you will) of the receptor has drifted or was improperly set. Because this part is a purchased subassembly, GI relies heavily on the vendor to assure performance compliance. Over time, or through the rigors of shipping, some of these reception cans may have become mistuned. The following procedure will help a qualified technician to reset the UHF can to the right frequency. Please be sure to disconnect the AC mains before attempting to service the unit.

6. An adjustment must be made to the last loop of the lower of the two coils to bring the UHF receptor back to the right frequency so it can respond to the hand held remote control signals. You should use a non-conductive tuning tool (commonly referred to as a "diddle stick") to spread the last turn of this coil about 1/8th of one inch. See Illustrations 4 and 5.
